Manhole Inspection Summary

Manhole # S45CC_001MH

Insp Date: **12/21/07 10:20 AM**

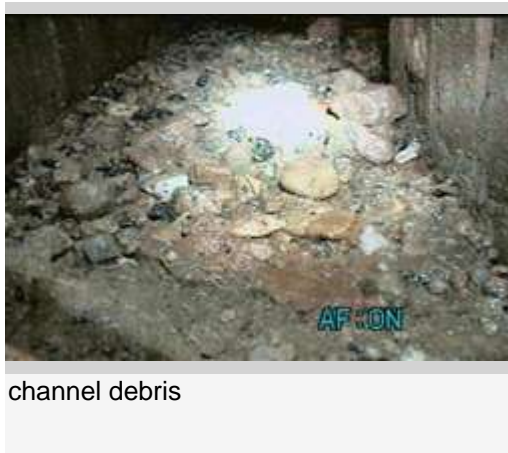
Defect 5

Condition: ☐ Sound ☐ Cracked ☐ Root Intrusion ☐ Deteriorated ☐ Leaks ☒ **Debris**

channel debris

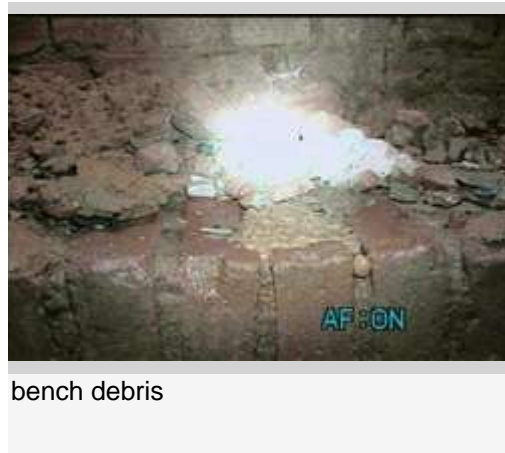
Defect 4

Condition: ☐ Sound ☐ Cracked ☐ Root Intrusion ☐ Deteriorated ☐ Leaks ☒ **Debris**

bench debris

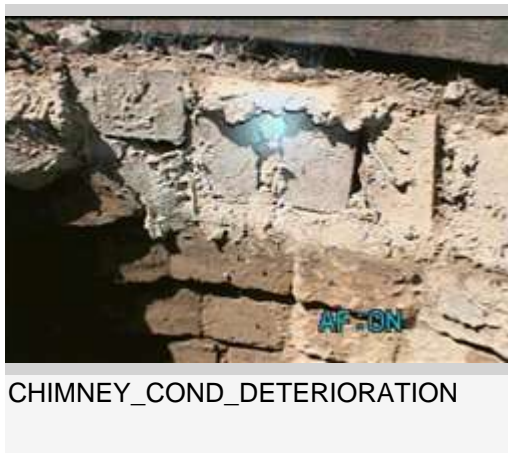
Defect 3

Condition: ☐ Sound ☐ Cracked ☐ Root Intrusion ☐ Loose Brick ☒ **Deteriorated**

CHIMNEY_COND_DETERIORATION

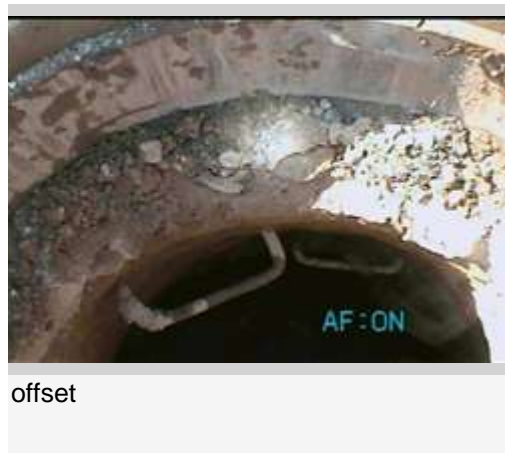
Defect 2

Offset: **4** (in.)

offset

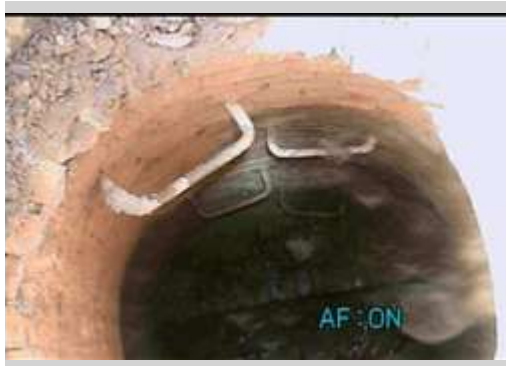
Defect 1

Count: **4** Missing: **0** ☒ **Corroded**

steps

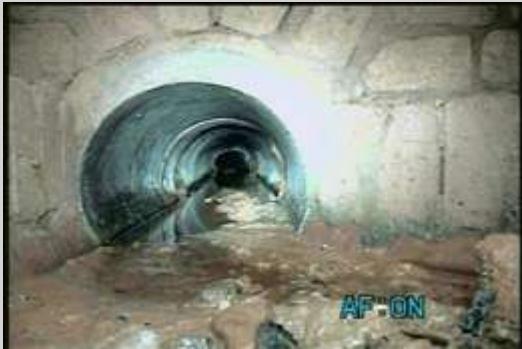
12 O'Clock Outflow

8 in. Circular Gravity Sewer
Pipe Out @ 12 O'Clock

Invert Depth: 8.25 (ft.) Flow Characteristics: **Slow**

Deposits: ☐ None ☒ **Mud** ☐ Sludge ☒ **Debris** ☐ Grease

Silt Depth: 3 (in.) Deposits Extent: **Medium**

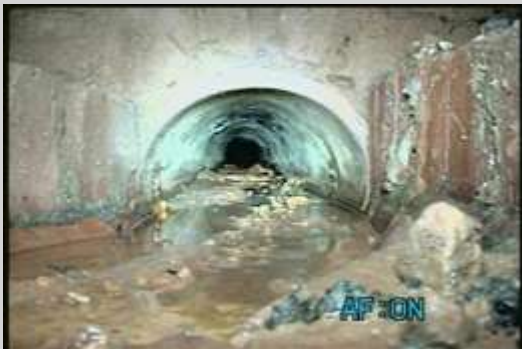
3 O'Clock Inflow

8 in. Circular Gravity Sewer
Pipe In @ 3 O'Clock

Invert Depth: 8.10 (ft.) Flow Characteristics: **Slow**

Deposits: ☐ None ☒ **Mud** ☐ Sludge ☒ **Debris** ☐ Grease

Silt Depth: 3 (in.) Deposits Extent: **Medium**

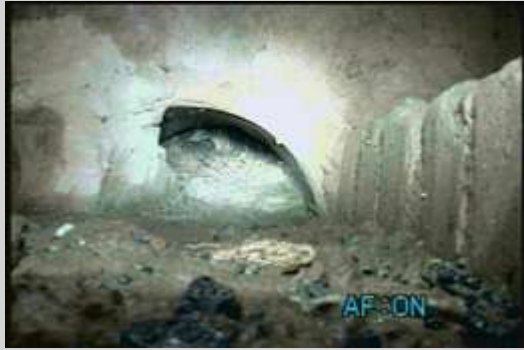
6 O'Clock Inflow

8 in. Circular Gravity Sewer
Pipe In @ 6 O'Clock

Invert Depth: 8.10 (ft.) Flow Characteristics: None

Deposits: ☐ None ☒ Mud ☐ Sludge ☒ Debris ☐ Grease

Silt Depth: 7 (in.) Deposits Extent: Heavy
